REPAIR, EVALUATION, MAINTENANCE, AND  
REHABILITATION RESEARCH PROGRAM

TECHNICAL REPORT REMR-CO-2

PROTOTYPE EXPERIENCE WITH THE USE  
OF DISSIMILAR ARMOR FOR REPAIR AND  
REHABILITATION OF RUBBLE-MOUND  
COASTAL STRUCTURES

Robert D. Carver

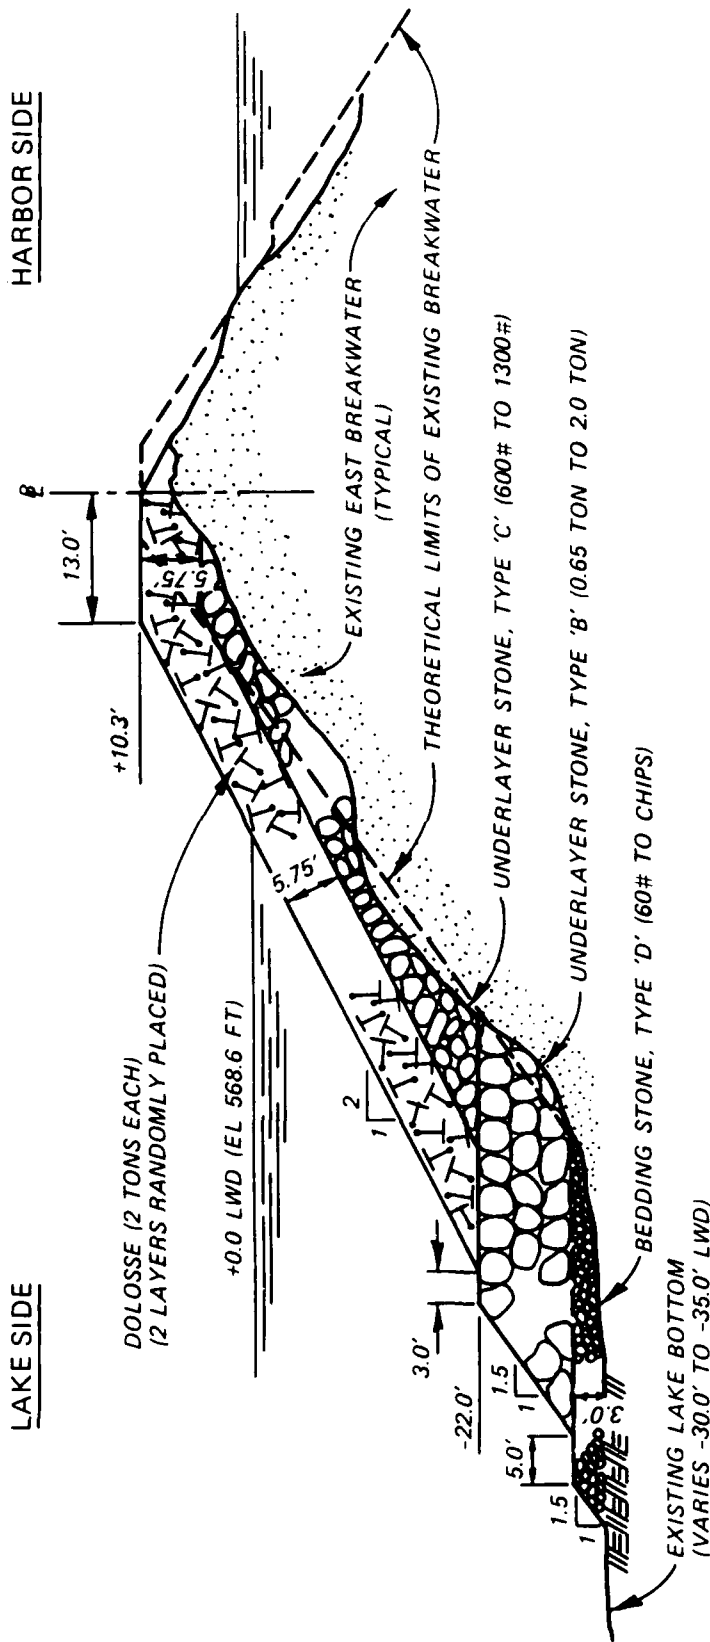
SECTION OF BREAKWATER TRUNK

CONCRETE ARMOR UNIT DESIGN,  
BREAKWATER TRUNK  
(CLEVELAND HARBOR EAST BREAKWATER  
1980 REHABILITATION)

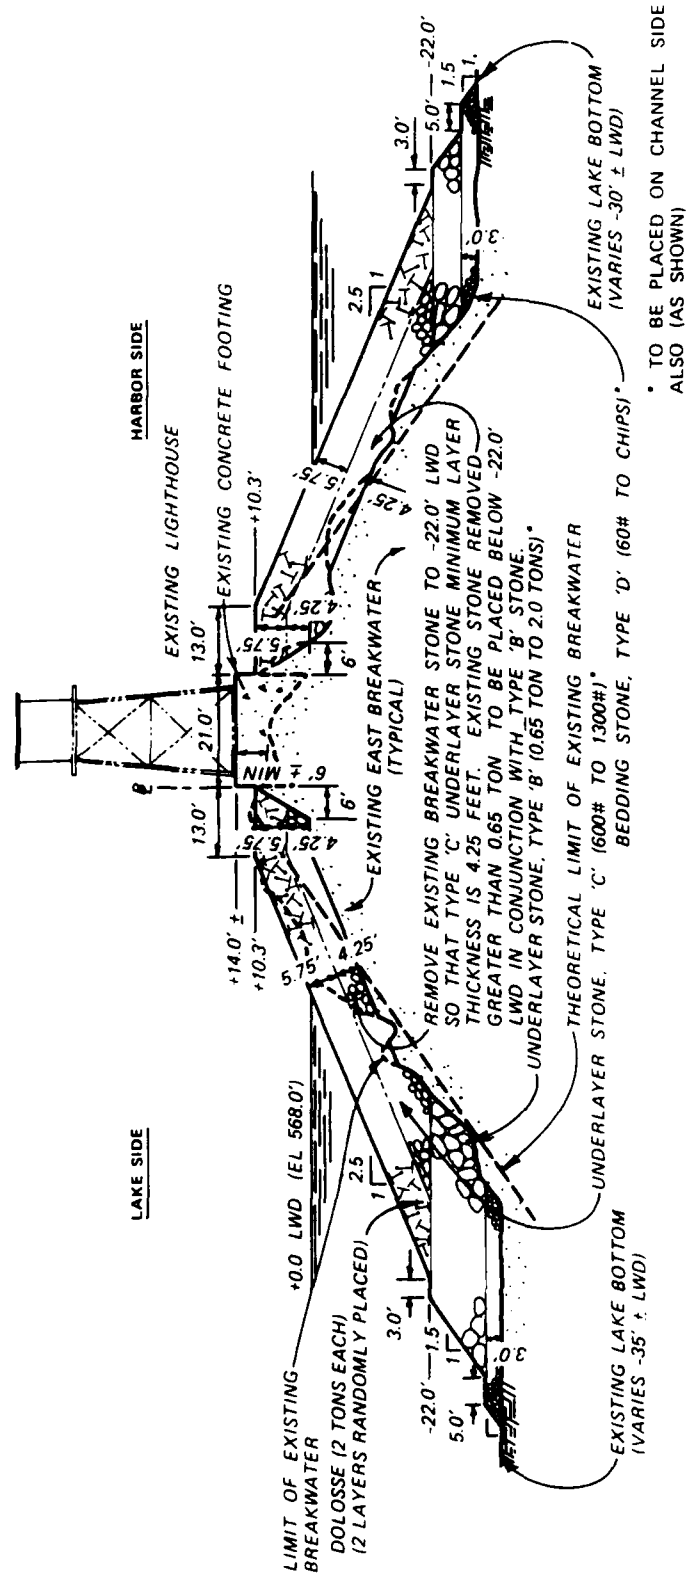
SECTION OF BREAKWATER HEAD

CONCRETE ARMOR UNIT DESIGN,  
BREAKWATER HEAD  
(CLEVELAND HARBOR EAST BREAKWATER  
1980 REHABILITATION)

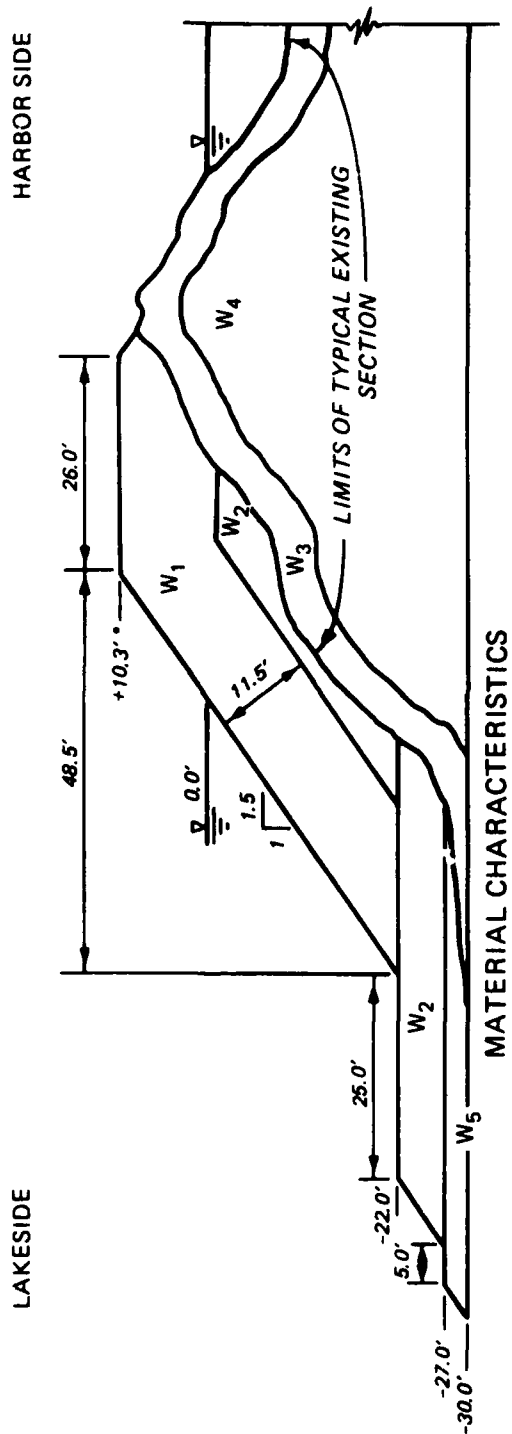
TYPICAL SECTION  
CLEVELAND HARBOR BREAKWATER  
1985 REHABILITATION  
9-TO-20-TON ARMOR STONE

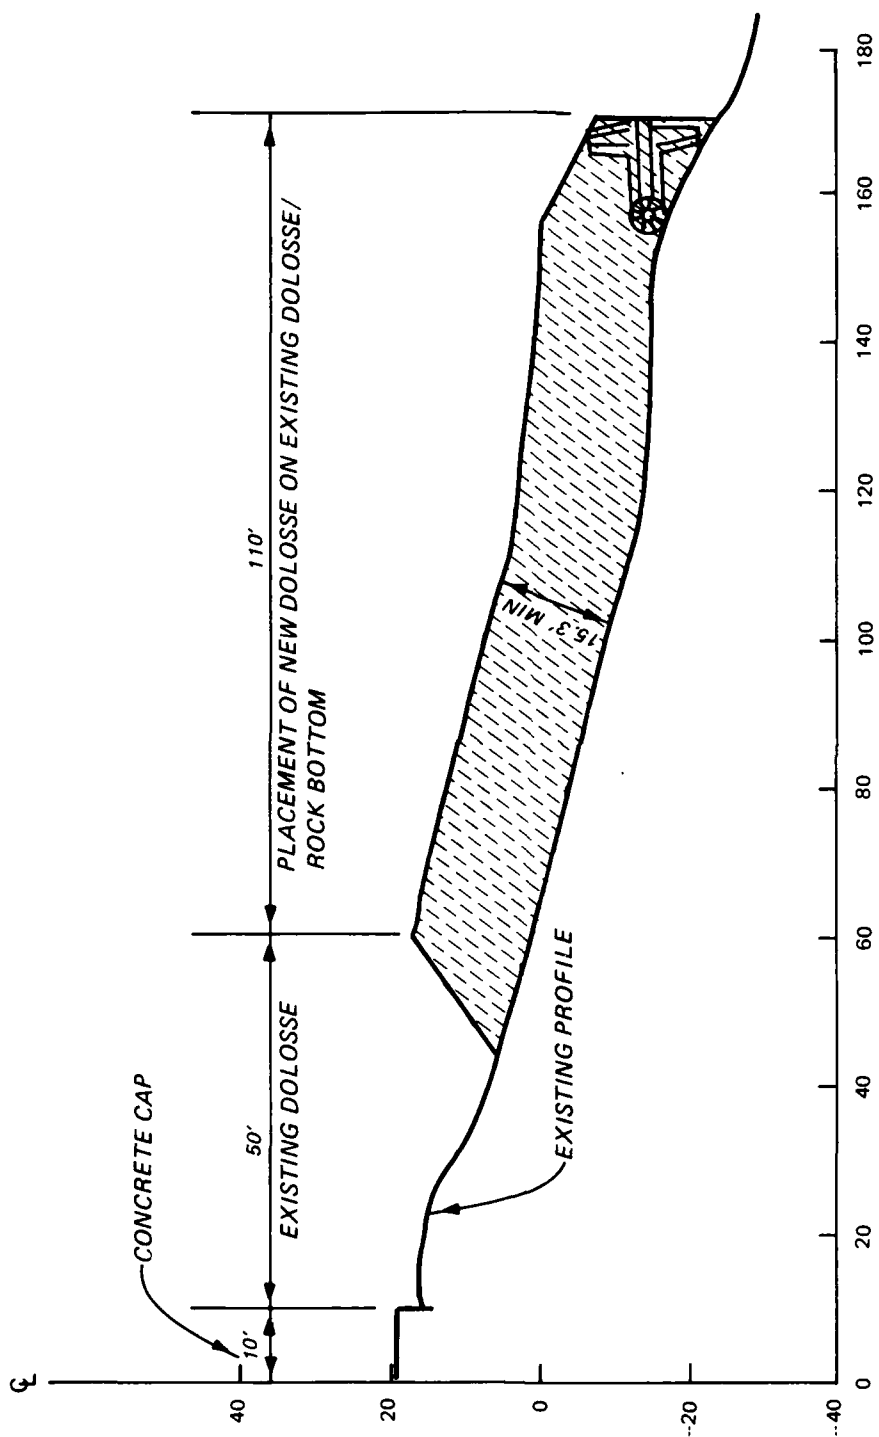
TYPICAL SECTION  
CRESCENT CITY HARBOR BREAKWATER  
1986 REHABILITATION  
42-TON DOLOS

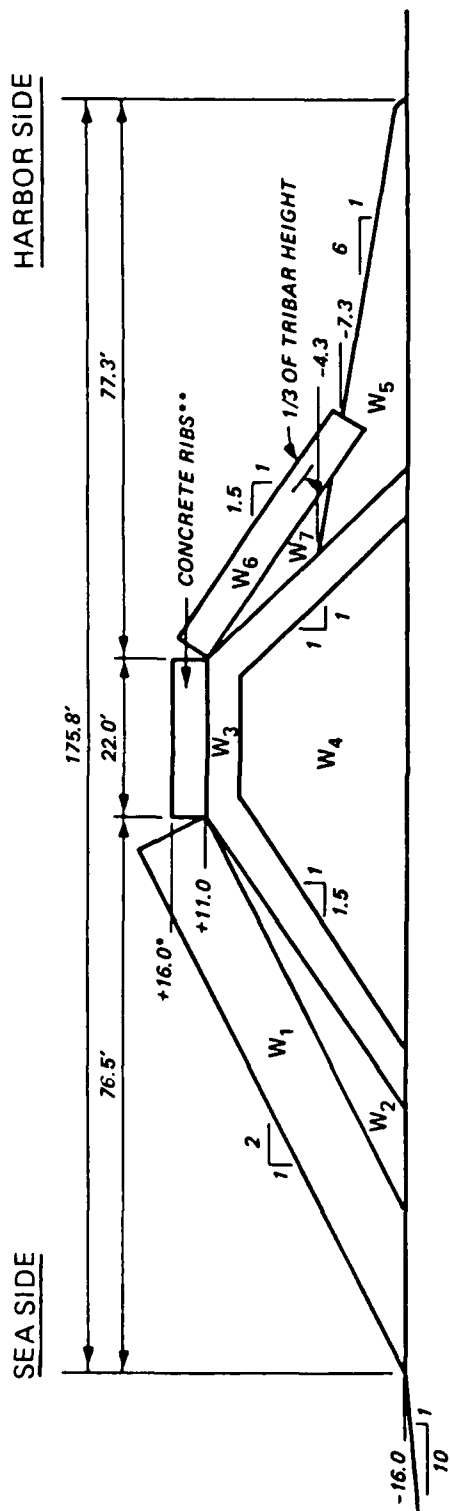
### TYPICAL TRUNK SECTION NAWILIWILI HARBOR BREAKWATER

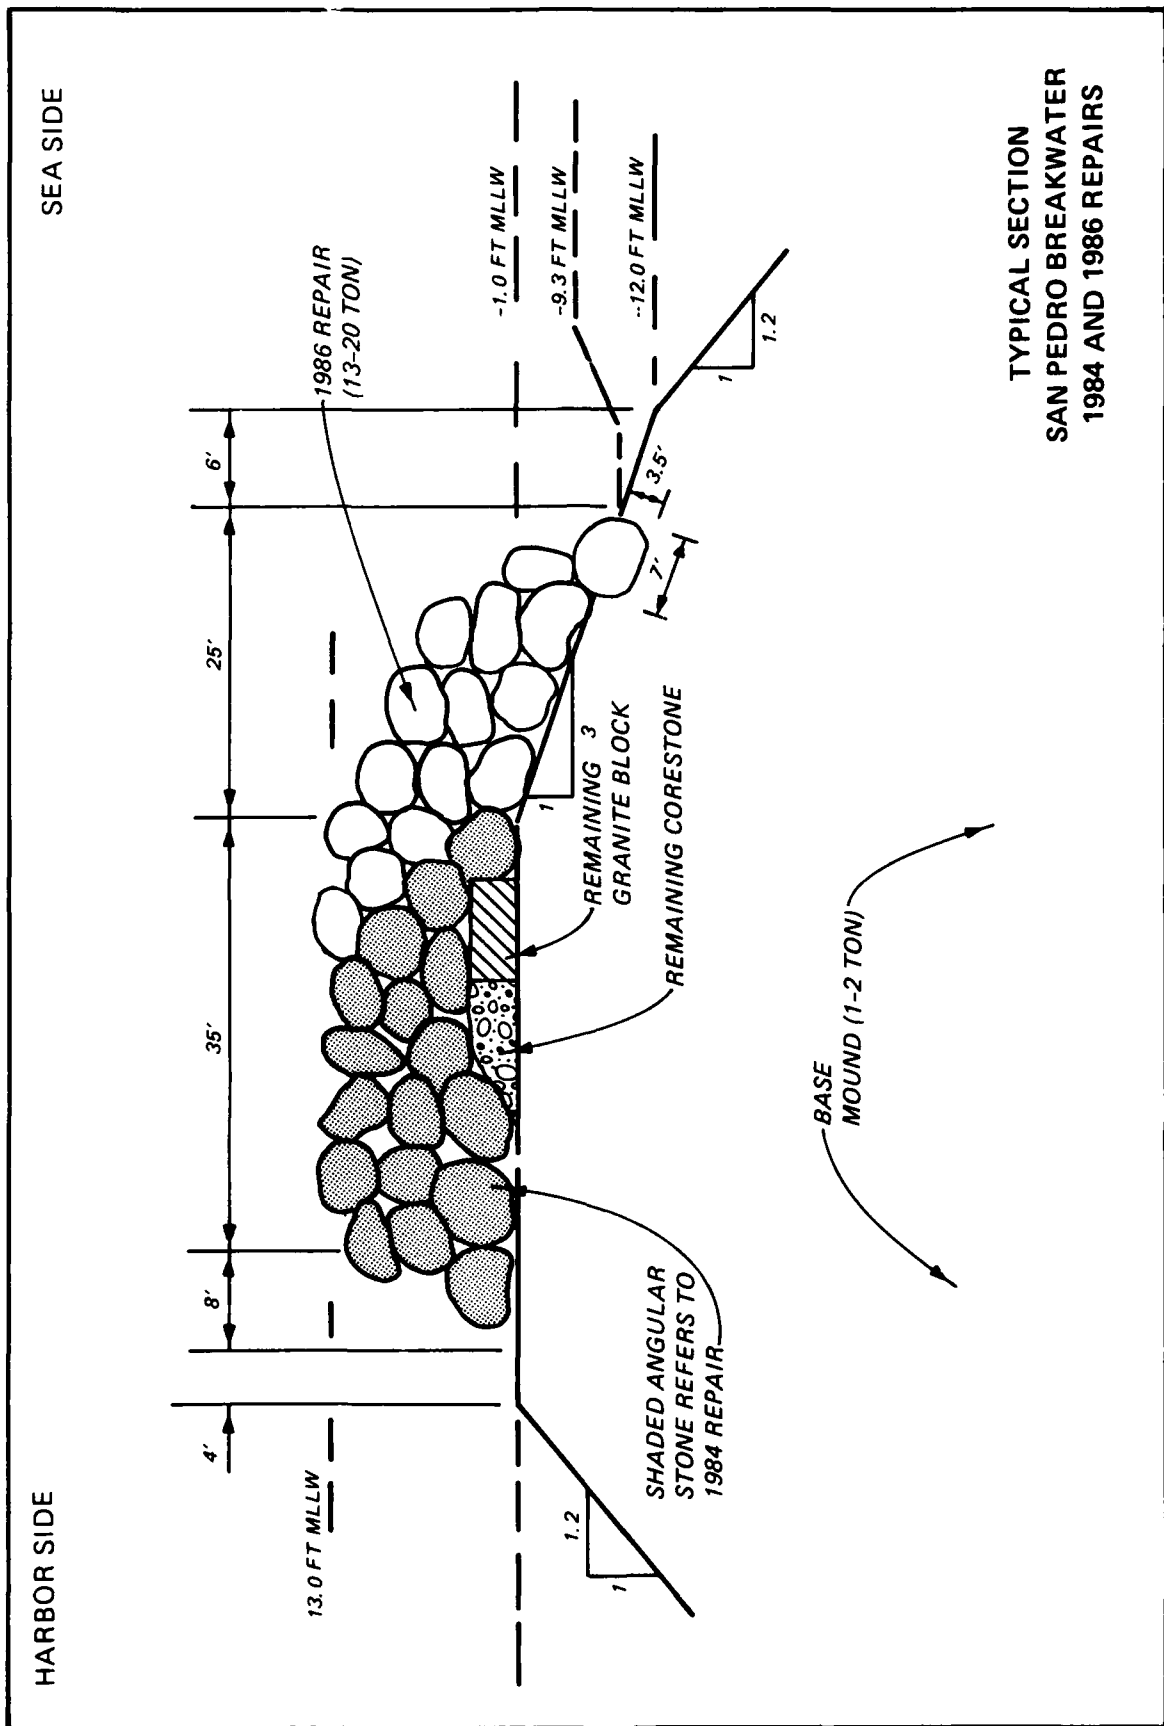
TYPICAL SECTION  
SAN PEDRO BREAKWATER  
1984 AND 1986 REPAIRS
